CMER MARSH EXPANSION MONITORING

Year 1 – 2019 Monitoring Report

Prepared for
Marin Audubon Society

January 2020

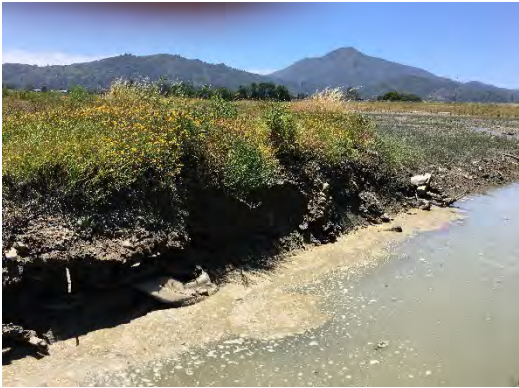
Evidence of channel erosion was noted in XS-CHAN 1 and XS-CHAN 2 and can be seen in **Table 3-2**. Both channels have experienced scour and some scarping as they are beginning to widen in response to increased tidal prism within the site interior. The slump block located on the eastern bank of XS-CHAN 2, seen in Figure A-3 and formed as a result of channel widening, can also be seen in the table below.

<p>XS-CHAN 1 - Slope erosion and undercut banks, looking Southwest at south bank</p>

Since this is the first year of physical monitoring since construction, recommendations are limited for the geomorphic aspects of the site. The erosion seen in XS-CHAN 1 and XS-CHAN 2 should be monitored closely in the following survey, but channel erosion and widening is an expected response as the channels work towards achieving equilibrium. For vegetation monitoring, it is recommended to shift future surveys to earlier in the season (late June) to facilitate capture of flowering and relatively low growing species.

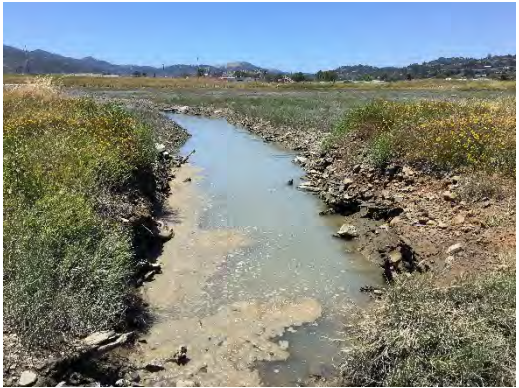
<p>XS-CHAN 1 – bank erosion in areas of higher marsh plain, looking West</p>

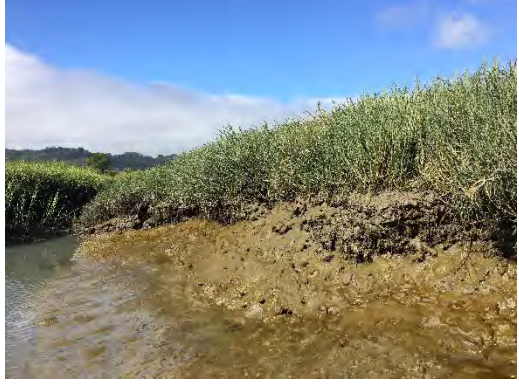
<p>XS-CHAN 2 – evidence of erosion near the high tide line below pickleweed on northwest bank of channel, looking West</p>

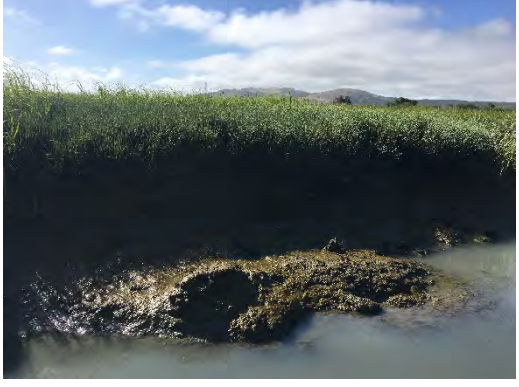
<p>XS-CHAN 2 - fallen slump block on southeast bank of channel, looking South</p>

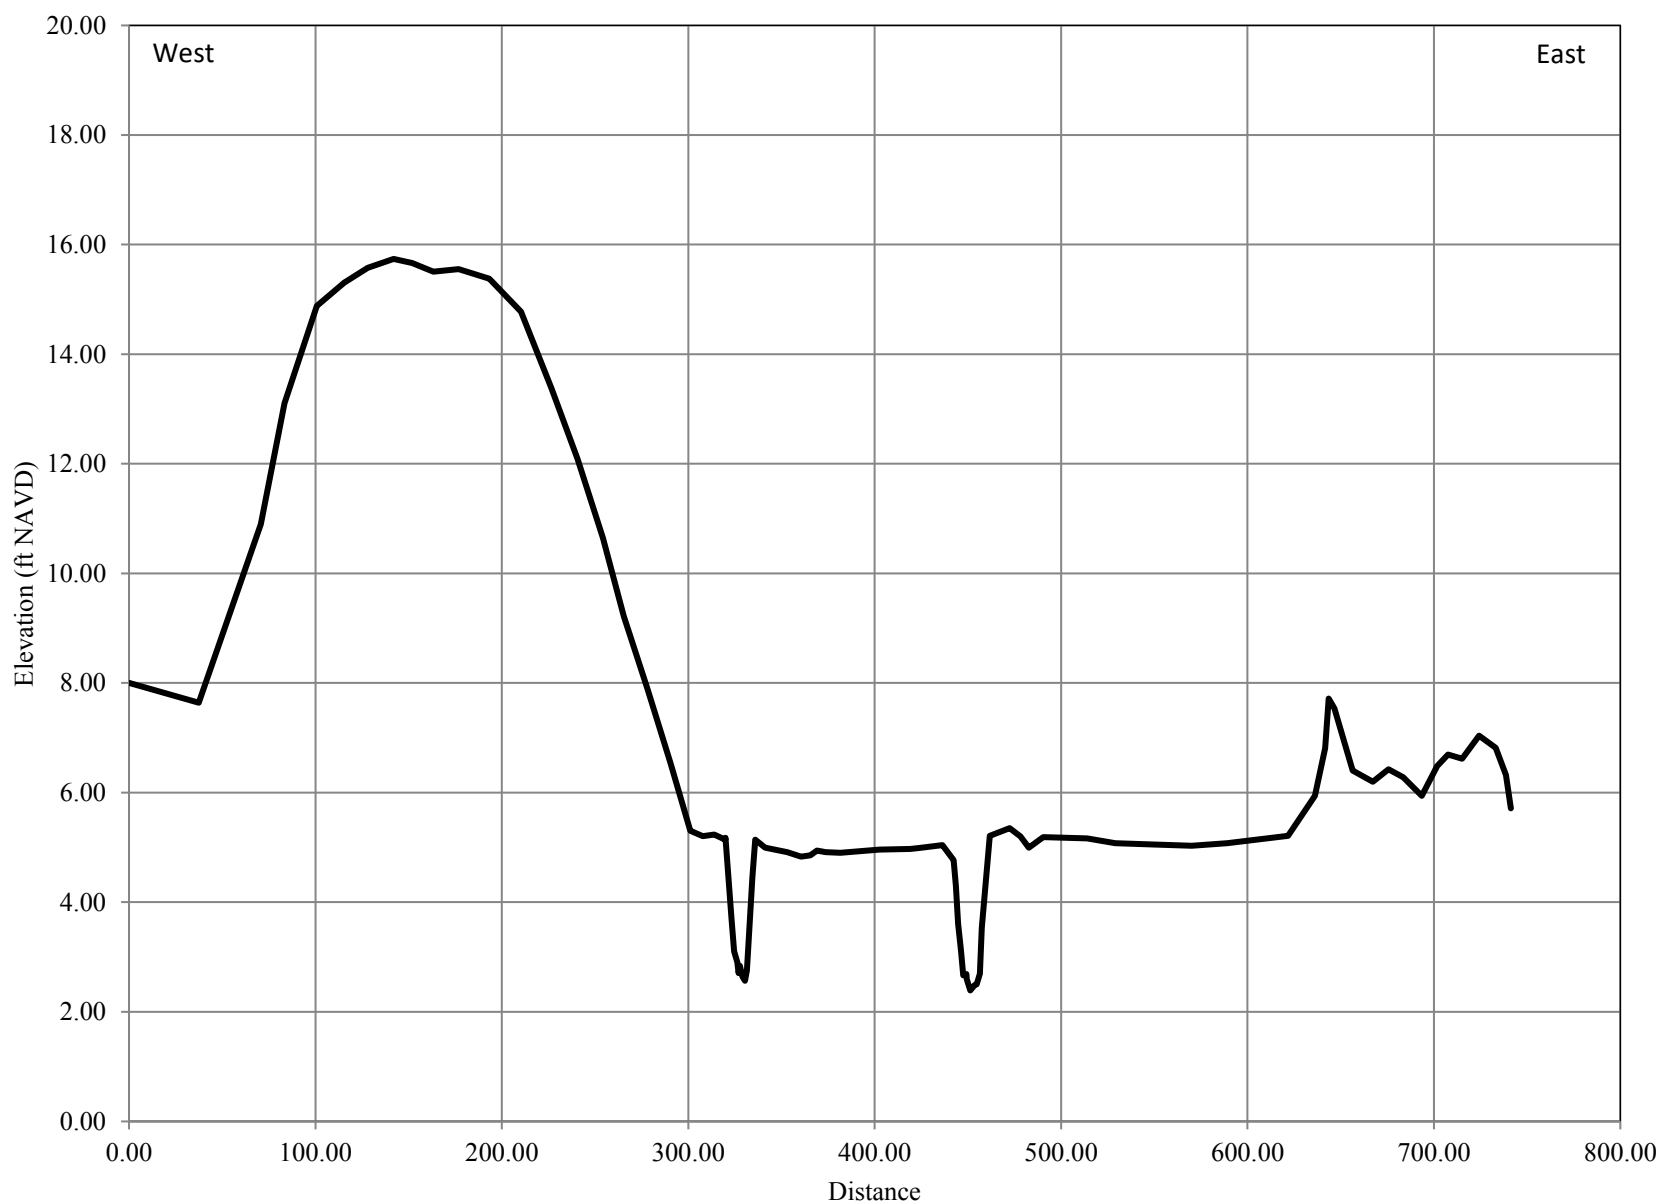
XS-WE, West to East
Site Transect

The marsh plain topography along transects XS-WE and XS-NS can be found in **Appendix A**. Transect XS-WE (**Appendix A-1**) runs west to east across the upland region and two tidal marsh channels and approximately 100 feet past the eastern site boundary. The transitional slope from the upland region down to the marsh plain can be seen sloping down at roughly a 9:1 slope, from approximately 15 ft NAVD down to 5 ft NAVD across 90 horizontal feet. Marsh plain begins at the eastern toe of that transitional slope at an elevation of approximately 5.3 ft NAVD. The two tidal channels are similar in depth with thalweg elevations of 2.6 and 2.4 ft NAVD from west to east, respectively. The eastern channel is approximately 10 feet wider than the western channel. The lowest part of the marsh plain along transect XS-WE is between the two tidal channels, which sits at an elevation of approximately 4.8 ft NAVD.

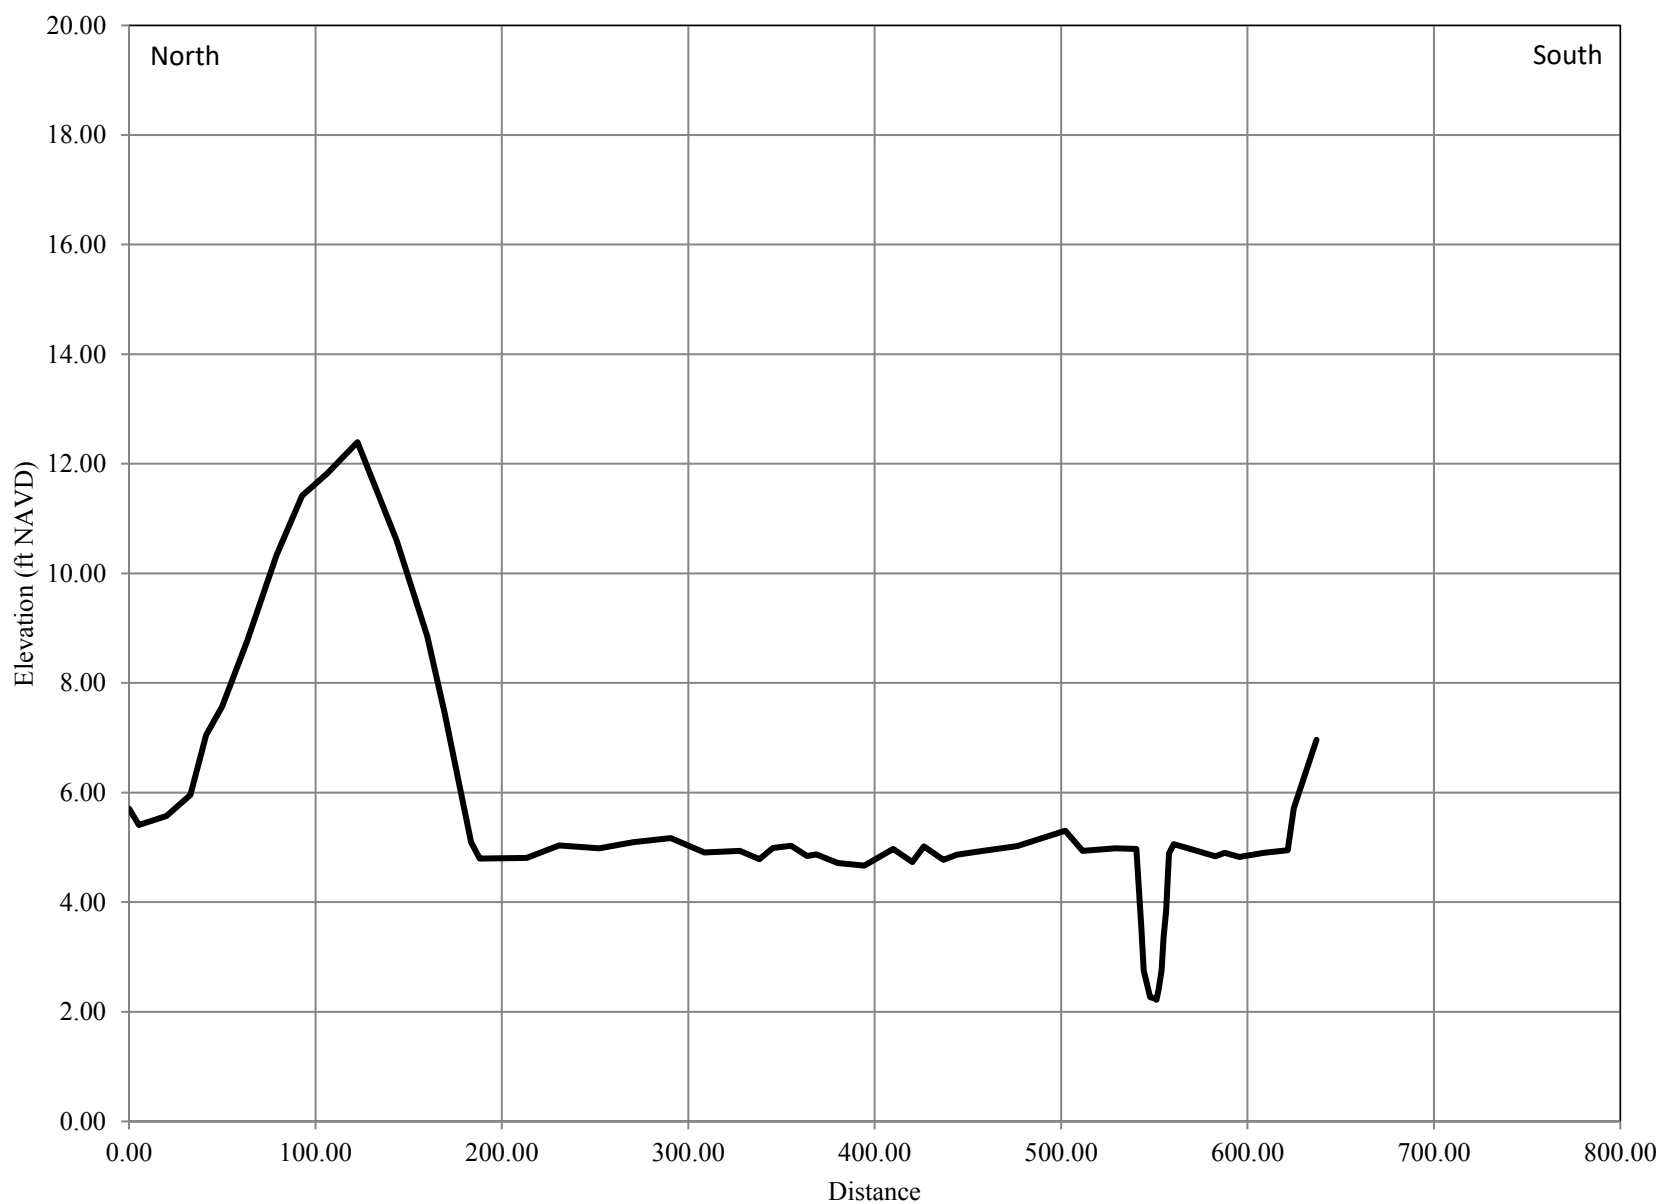
XS-NS, North to South
Site Transect

Transect XS-NS (**Appendix A-2**) runs north to south beginning at the MAS restored tidal channel, crossing the pre-existing mounded high ground west of the 2015 PG&E Tidal Restoration, then crossing the graded and restored marsh plain, including one tidal marsh channel, and ending just beyond the southern project boundary. The transect extends 175 feet beyond the project boundary to the north and 22 feet in the south. The transitional slope from the high ground down to the restored marsh plain slopes down from approximately 12.4 ft NAVD down to 4.8 ft NAVD across 68 horizontal feet, roughly an 8.5:1 slope. The restored marsh plain begins at 4.8 ft NAVD at the eastern toe of that slope and remains relatively consistent in elevation until the tidal channel is reached. The tidal channel here is approximately 20 feet wide with a thalweg elevation of 2.2 ft NAVD. This makes the channel slightly deeper and narrower here than seen on the same stem in XS-WE.

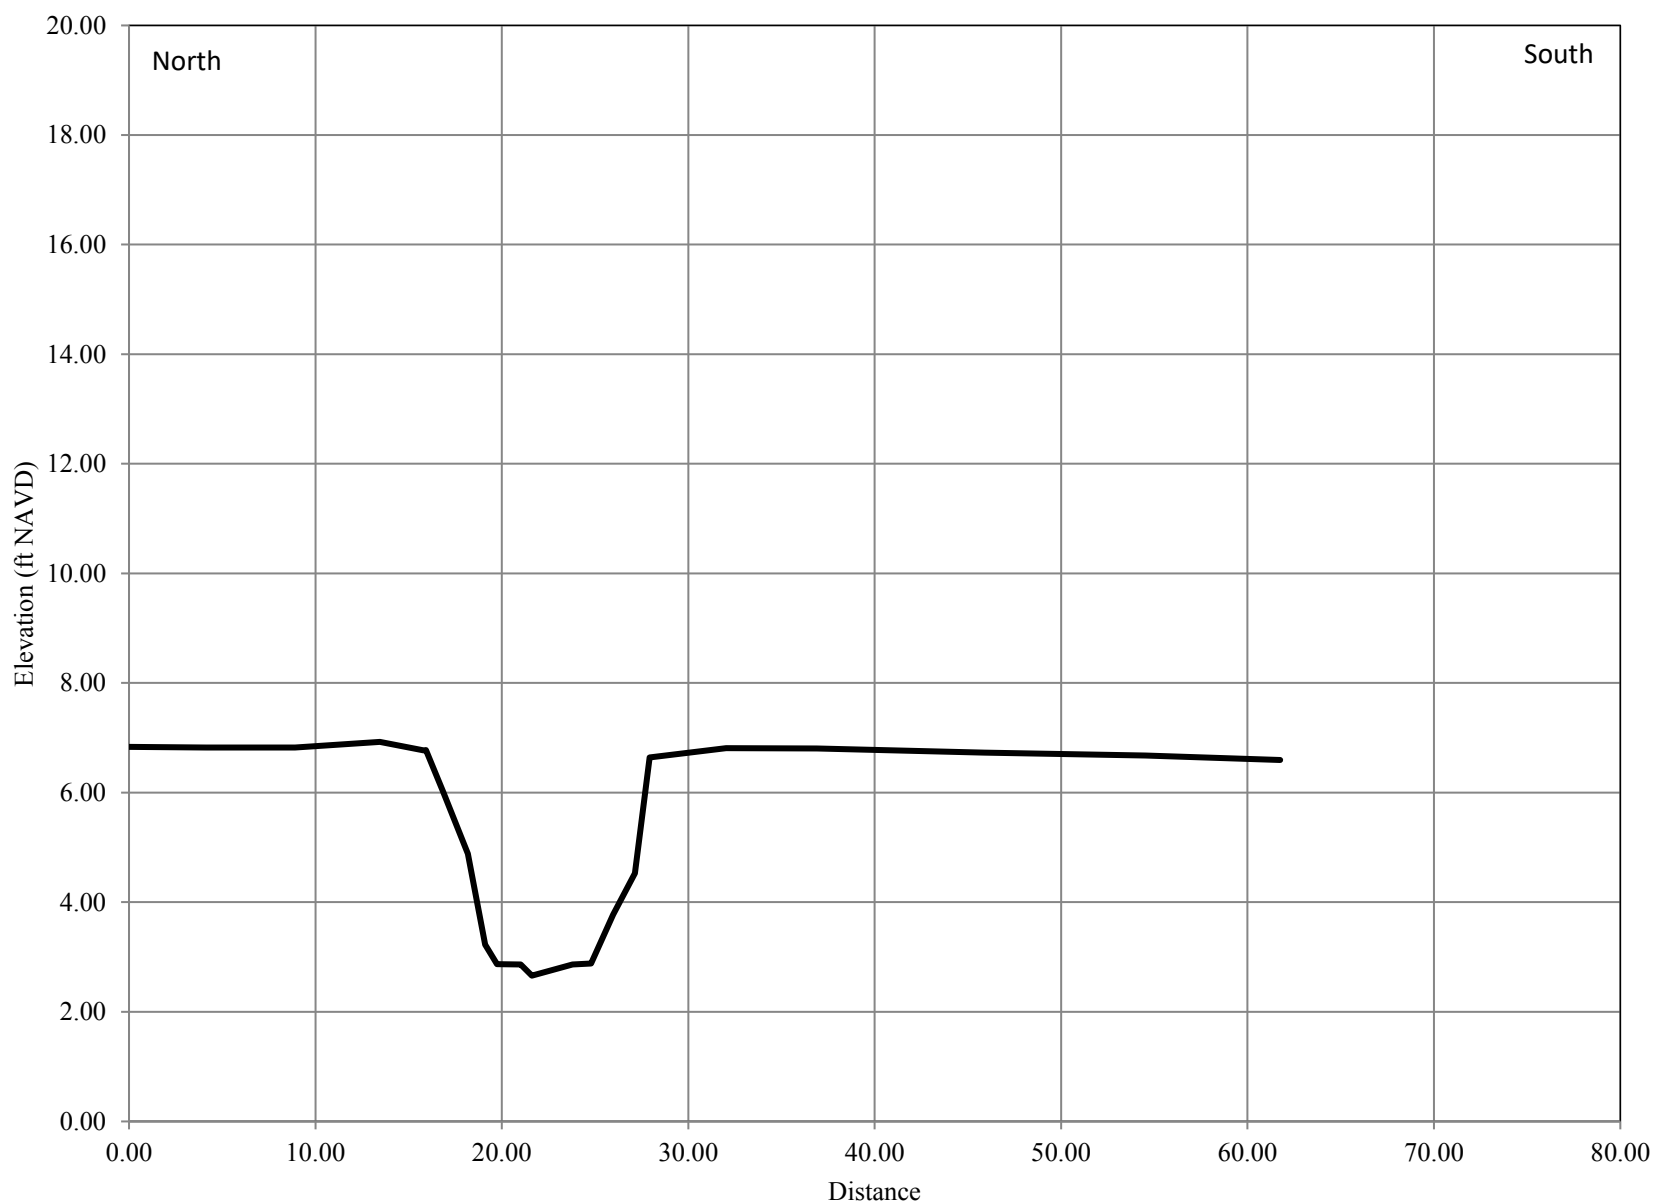
XS-Channel 1, North to South
Channel to East Pond

XS-CHAN 1 (**Appendix A-3**) crosses the channel to the east pond. Year 1 surveys found the channel to be approximately 12 feet wide with a thalweg of 2.7 feet NAVD. The cross section location lies just outside the construction area of impact, and crosses through mature marsh on either side of the channel, thus the marsh plain elevations being higher in elevation than seen in XS-WE or XS-NS. XS-CHAN 2 (**Appendix A-4**) crosses the south connector channel, with a thalweg of 0.3 feet NAVD and a channel width of approximately 25 feet. A fallen slump block as a result of erosion of the adjacent marsh plain can be observed on the east bank, starting at a station distance of 60 feet along the distance axis of the profile.
