CMER MARSH EXPANSION MONITORING

Year 1 – 2019 Monitoring Report

Prepared for
Marin Audubon Society

January 2020

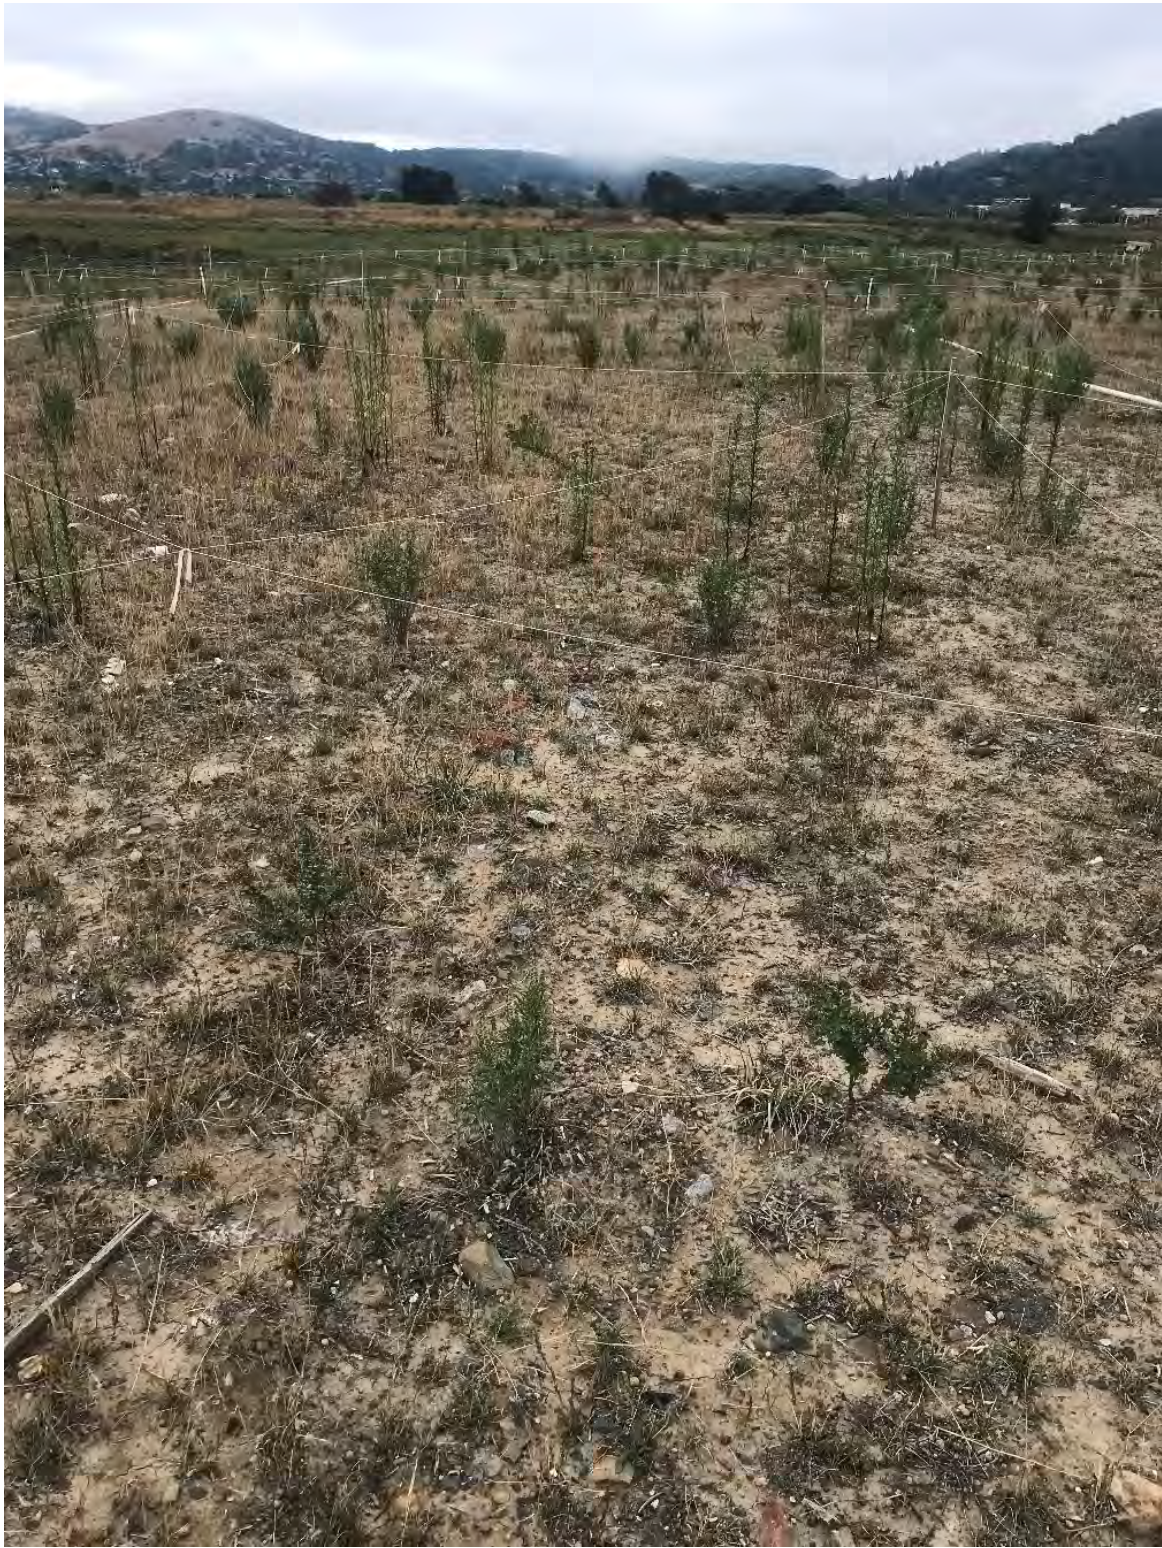
In July 2019 TWN conducted sampling along 8 randomly placed transects of 100' length and recorded height and vigor of any installed native species within 3' of transect line/ within. **Figure 6** shows the approximate locations of the 2019 transects. The total sampled area represents ~5% of the area of the restored transition and upland zones area of ~ 2.2 acres (The Watershed Nursery, 2019).

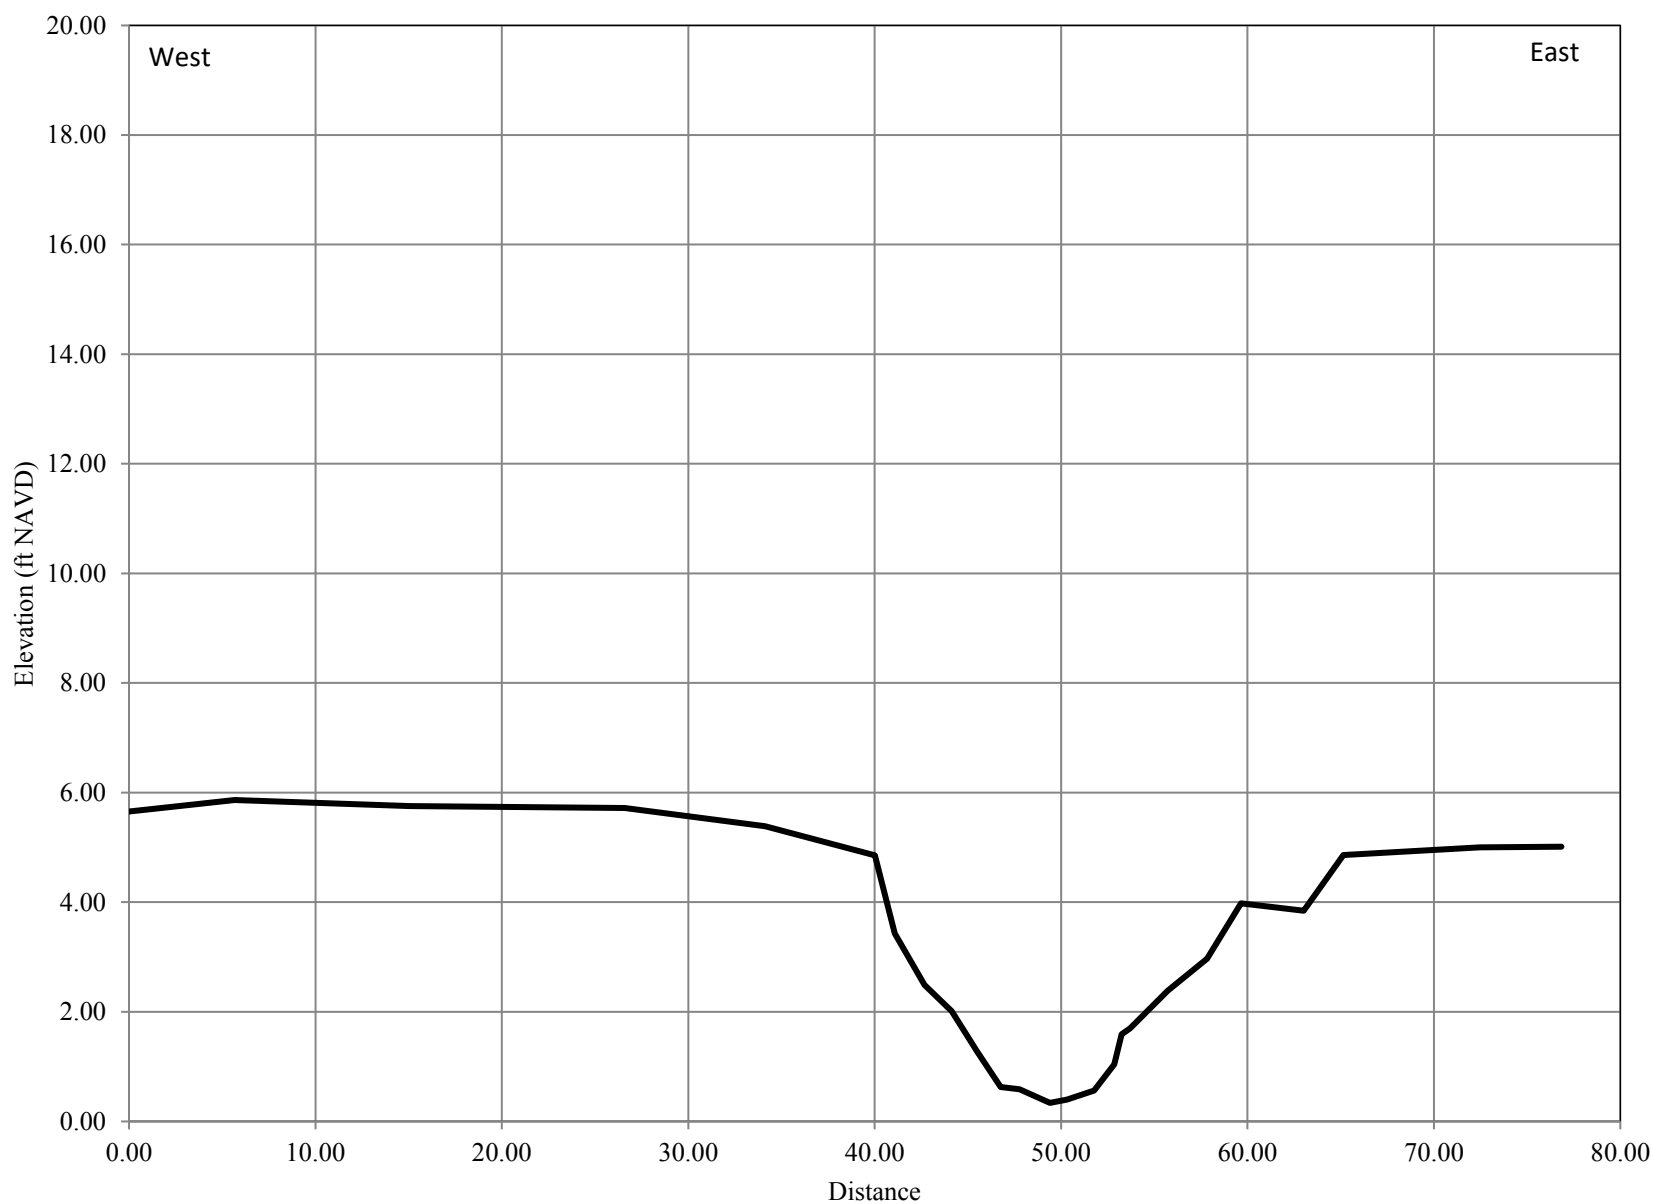
XS-Channel 1, North to South
Channel to East Pond

XS-CHAN 1 (**Appendix A-3**) crosses the channel to the east pond. Year 1 surveys found the channel to be approximately 12 feet wide with a thalweg of 2.7 feet NAVD. The cross section location lies just outside the construction area of impact, and crosses through mature marsh on either side of the channel, thus the marsh plain elevations being higher in elevation than seen in XS-WE or XS-NS. XS-CHAN 2 (**Appendix A-4**) crosses the south connector channel, with a thalweg of 0.3 feet NAVD and a channel width of approximately 25 feet. A fallen slump block as a result of erosion of the adjacent marsh plain can be observed on the east bank, starting at a station distance of 60 feet along the distance axis of the profile.

Evidence of channel erosion was noted in XS-CHAN 1 and XS-CHAN 2 and can be seen in **Table 3-2**. Both channels have experienced scour and some scarping as they are beginning to widen in response to increased tidal prism within the site interior. The slump block located on the eastern bank of XS-CHAN 2, seen in Figure A-3 and formed as a result of channel widening, can also be seen in the table below.

Since this is the first year of physical monitoring since construction, recommendations are limited for the geomorphic aspects of the site. The erosion seen in XS-CHAN 1 and XS-CHAN 2 should be monitored closely in the following survey, but channel erosion and widening is an expected response as the channels work towards achieving equilibrium. For vegetation monitoring, it is recommended to shift future surveys to earlier in the season (late June) to facilitate capture of flowering and relatively low growing species.

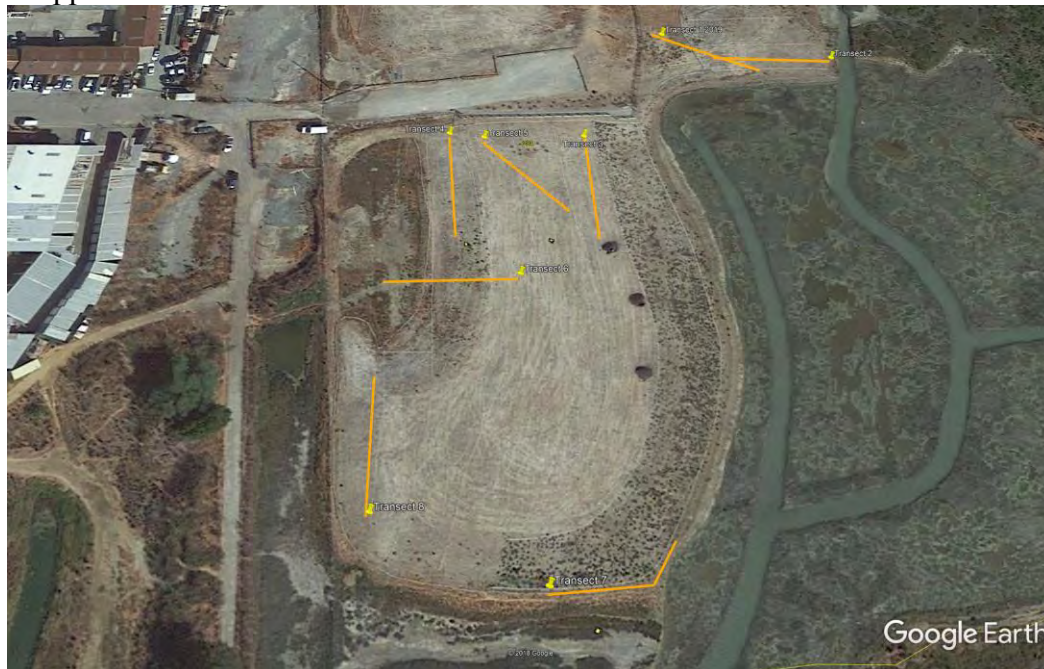
Figure 1: Approximate location of 2019 transects

TWN Vegetation Ecologist Diana Benner conducted transect monitoring of the Corte Madera site on July 19th and 26th, 2019. The approximate location of transects is depicted in Figure 1. Accuracy of gps readings averaged 16.5'.
